FOR RECOMMENDATION**PUBLIC****OPEN SESSION**

DATE: February 1, 2024 for February 8, 2024

Capital Project (Level 3): Report of the Project Planning Committee for University of Toronto Mississauga Residence (Phase IX) – Project Scope and Sources of Funding

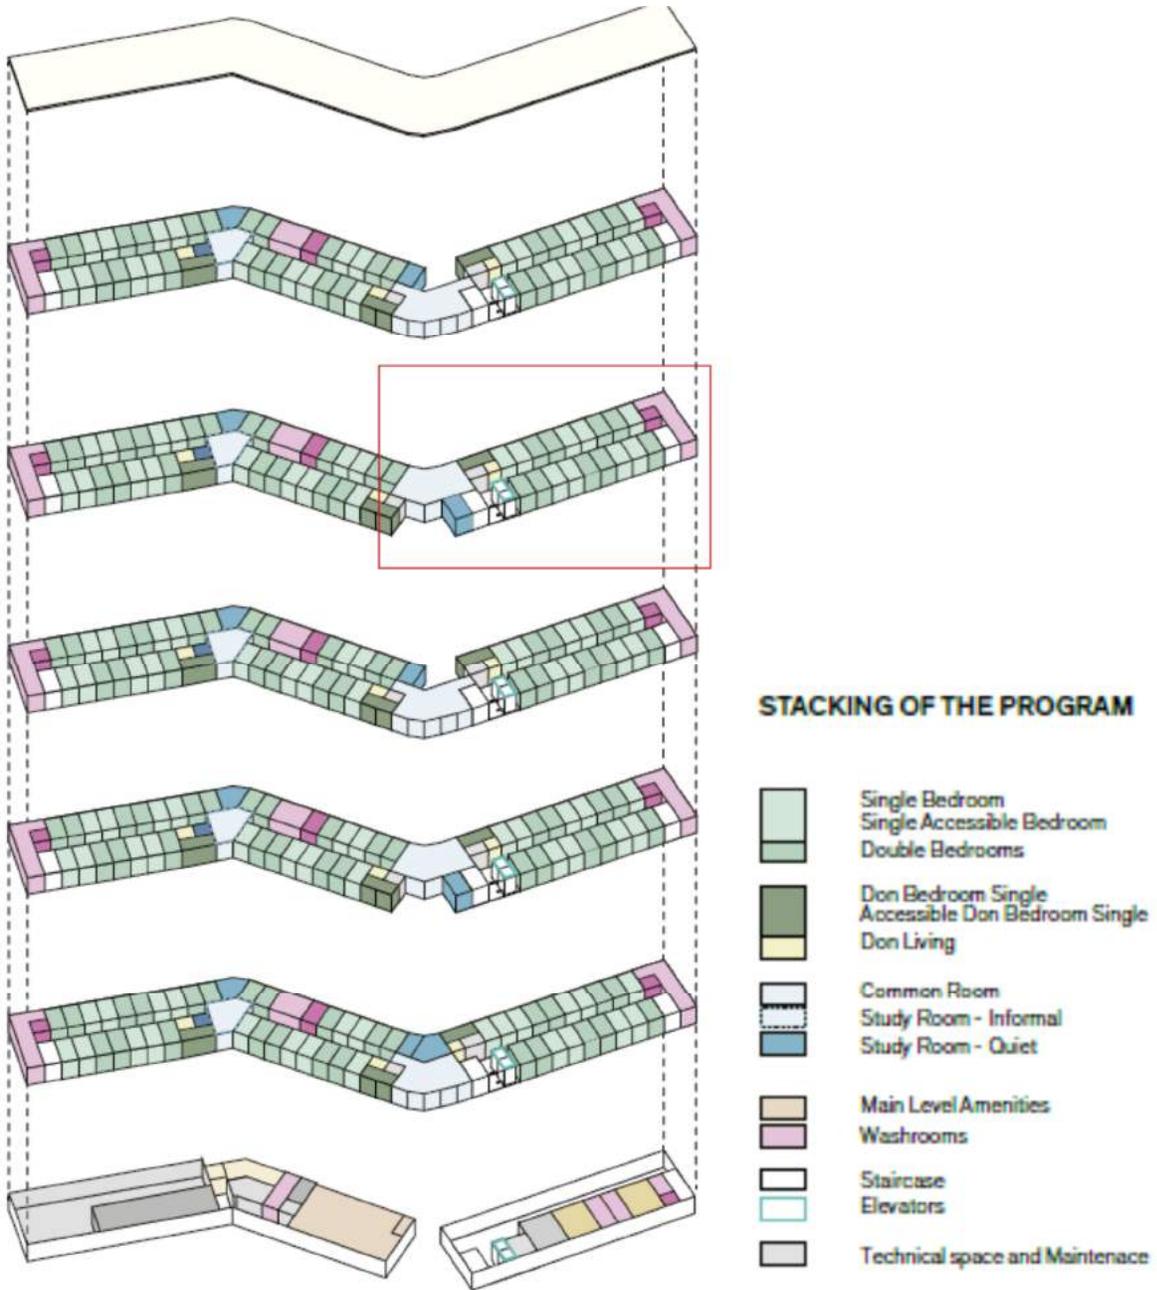
Figure 1.3 Building Stacking Opportunities (Christensen & Co/ Montgomery Sisam)

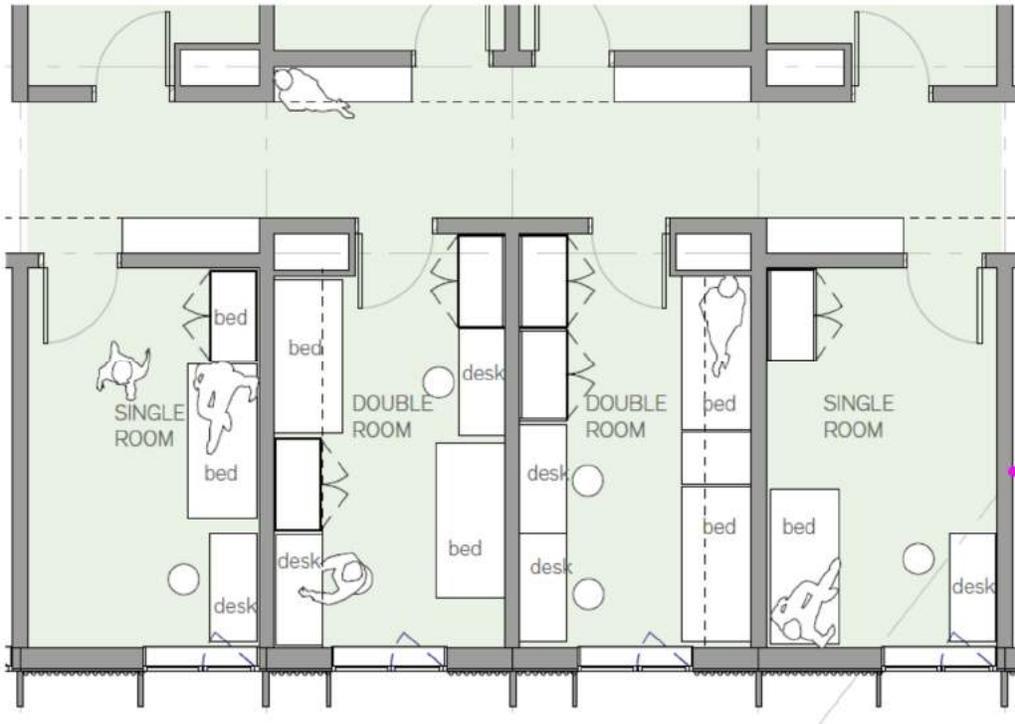
Figure 1.5 Suite Typologies; Single, Double and Accessible Suite Layouts (Christensen & Co/ Montgomery Sisam)

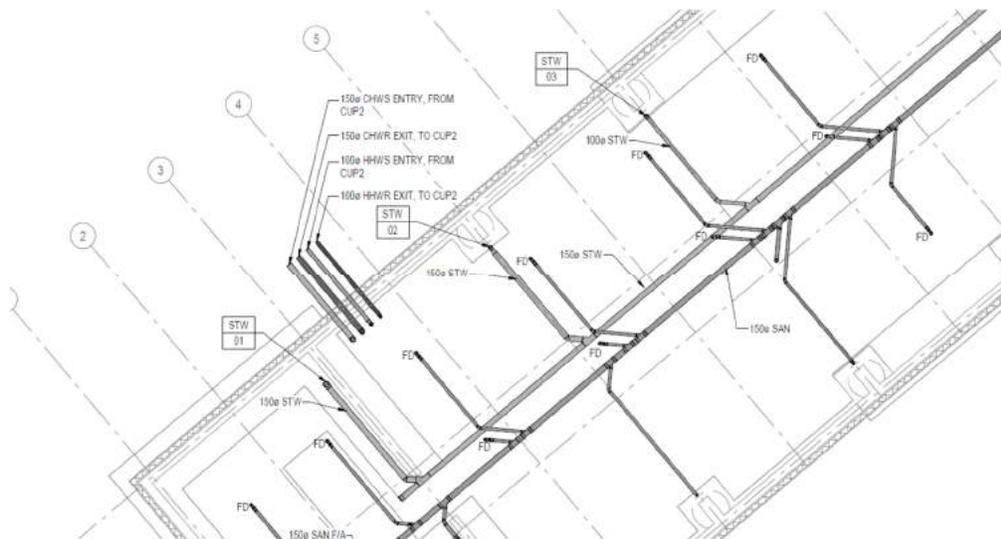
Figure 2.0 Central Utilities Plant Connection

Upon completion of the F2 Building, the project will connect to CUP-2 which is the expansion of the system along Outer Circle Road.

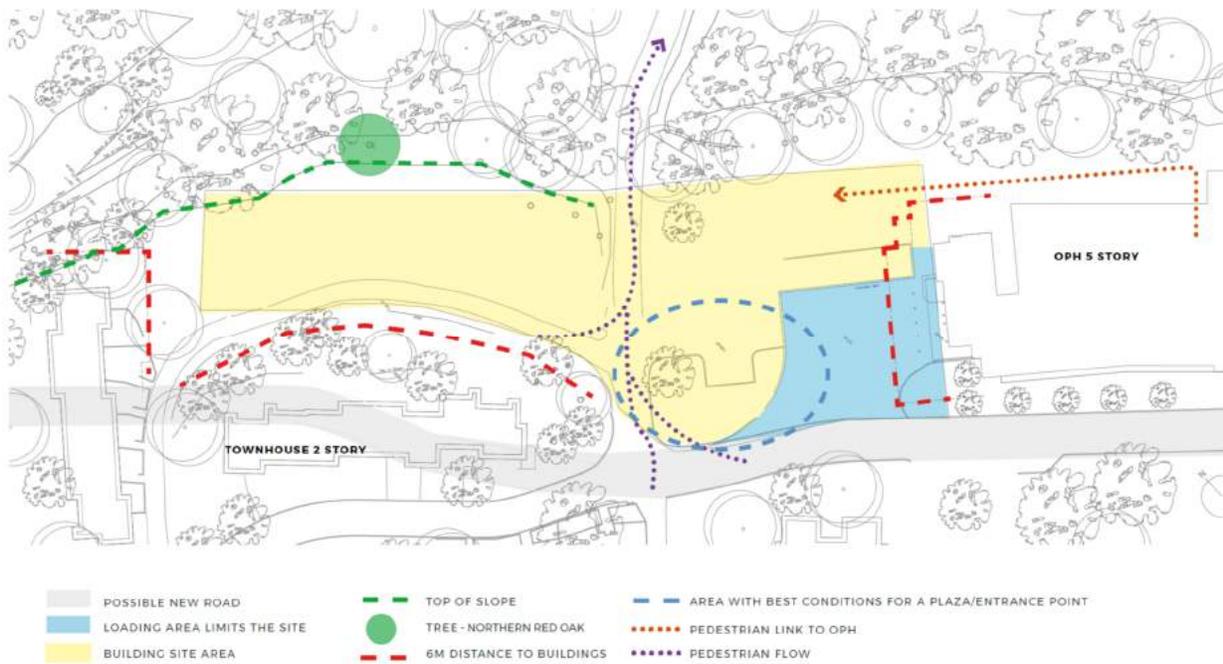
Figure 2.1 Context Plan (Christensen & Co/ Montgomery Sisam)

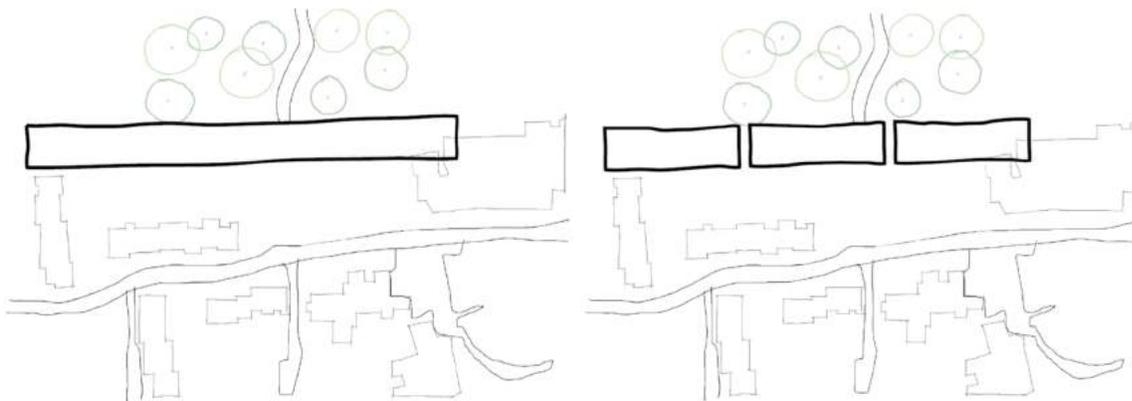
Figure 2.2 Massing Evolution (Christensen & Co/ Montgomery Sisam)

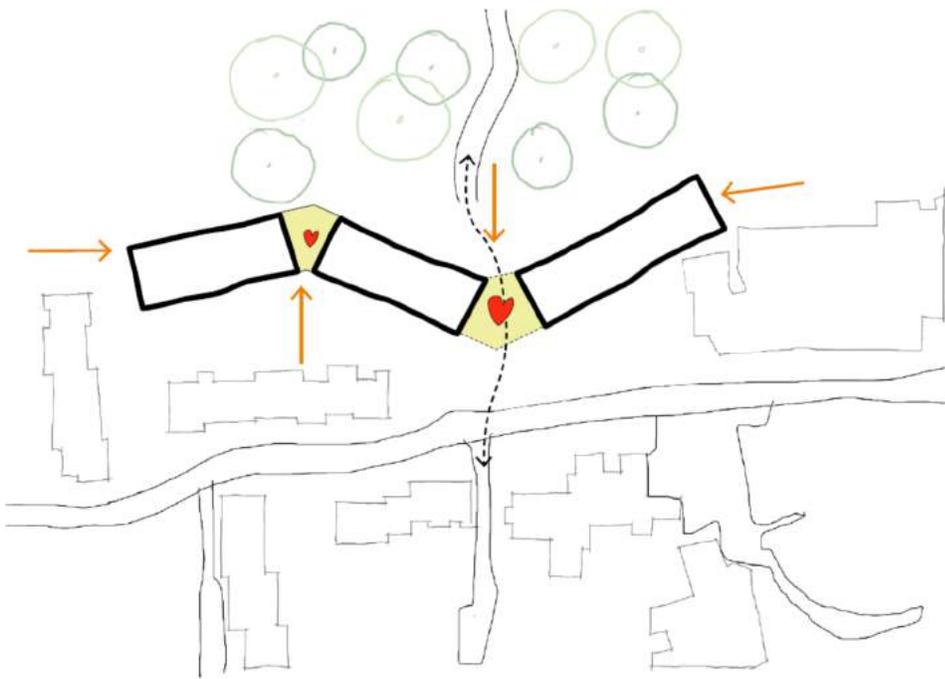
Figure 2.3 Site Opportunities (Christensen & Co/ Montgomery Sisam)

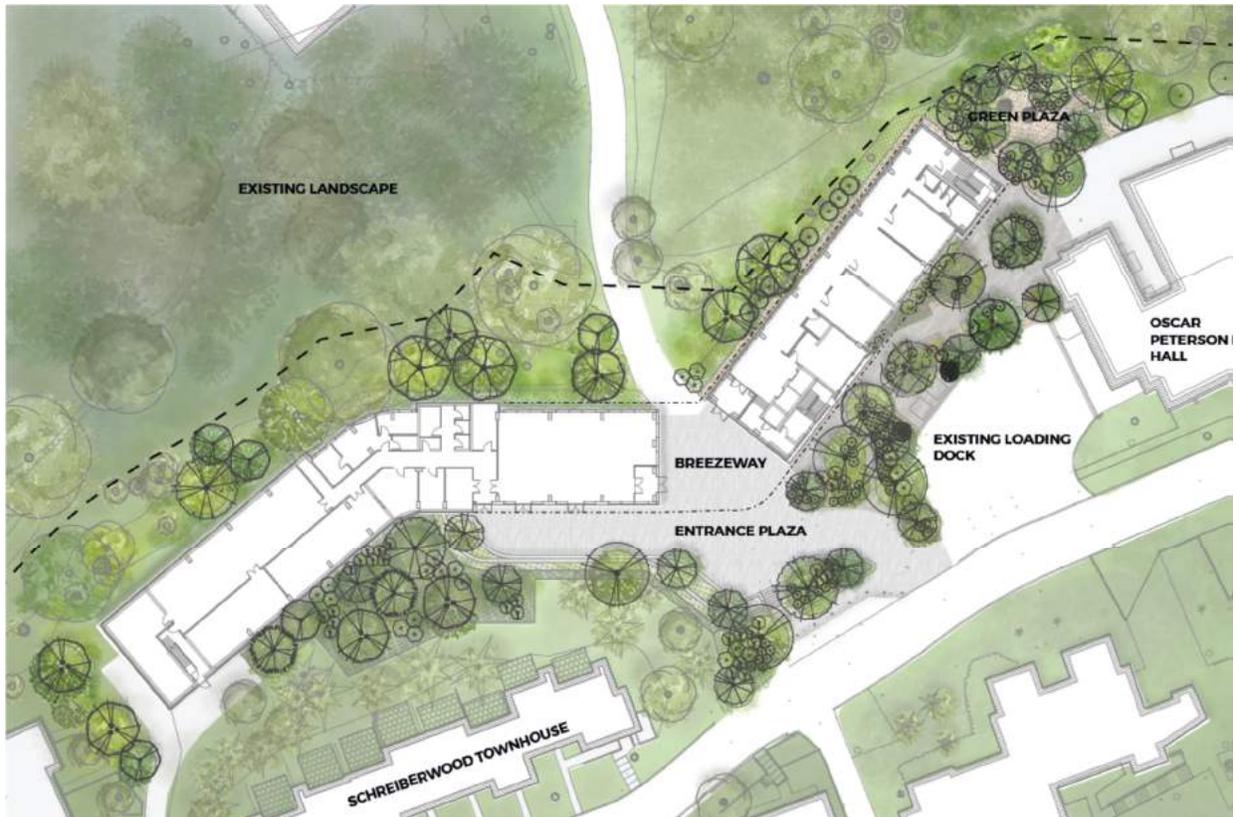
Figure 2.4 Site Concept Plan (Christensen & Co/ Montgomery Sisam)

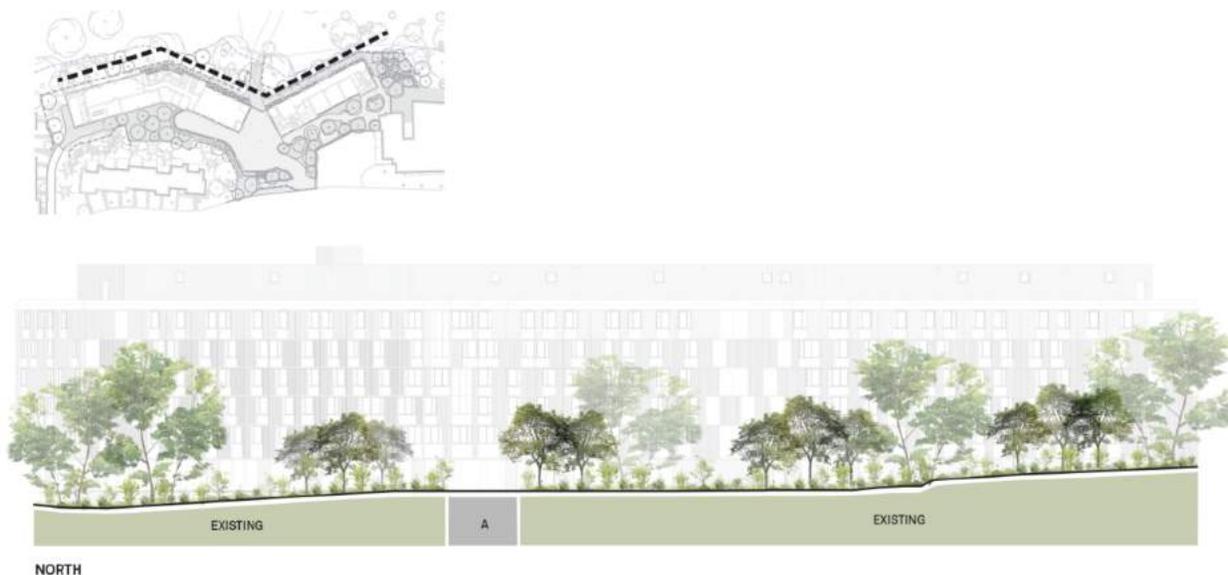
Figure 2.5 North Section; Grade evolution (Christensen & Co/ Montgomery Sisam)

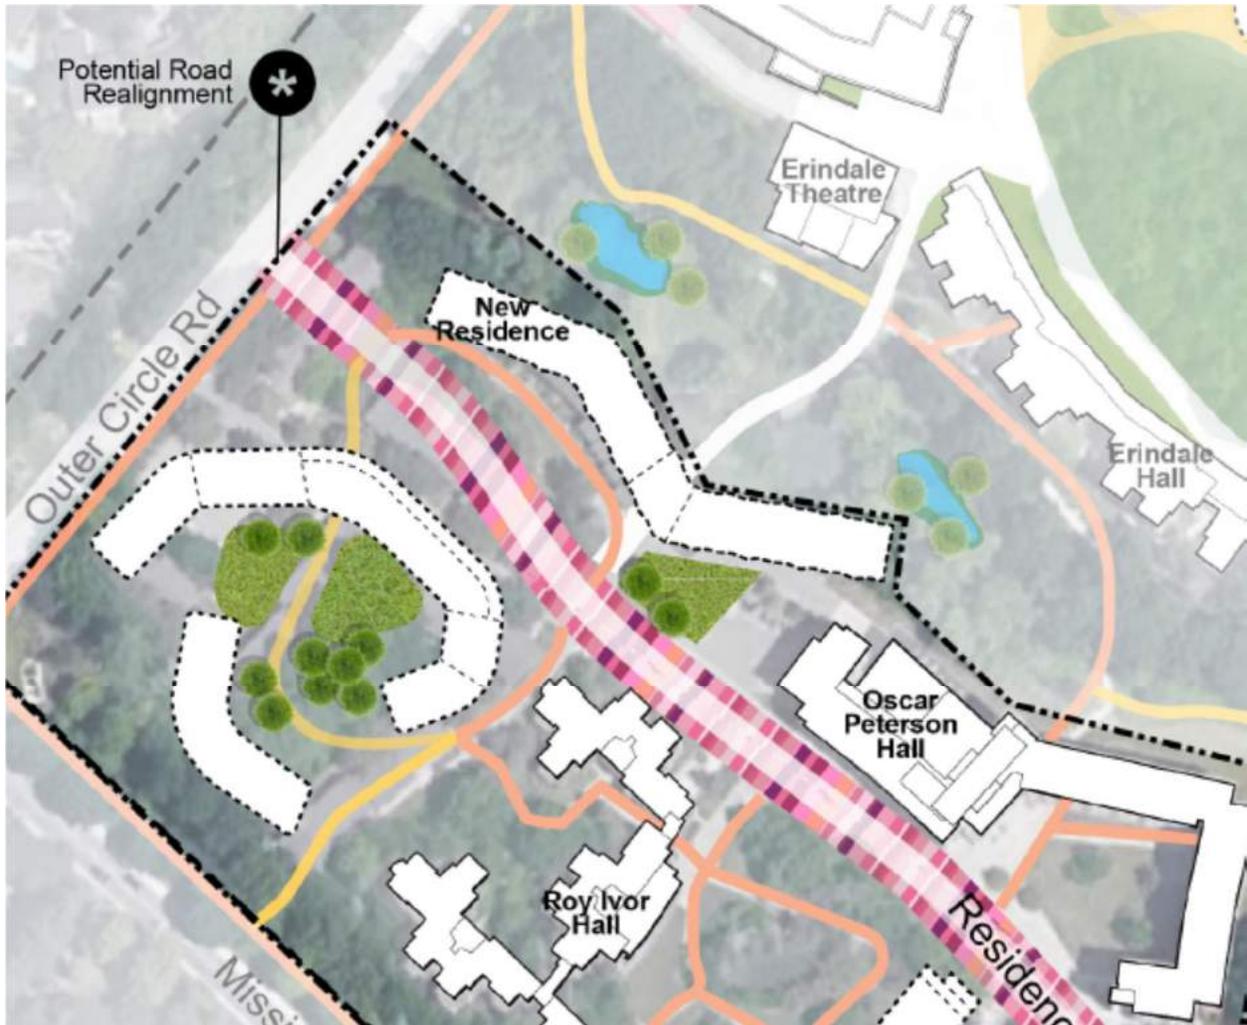
Figure 2.6 Master Plan analysis with New Residence with road realignment

The proposed massing studies included in this report are consistent with the studies of this site by BMI as illustrated in *Figure 2.6 Master Plan analysis with New Residence with road realignment*.

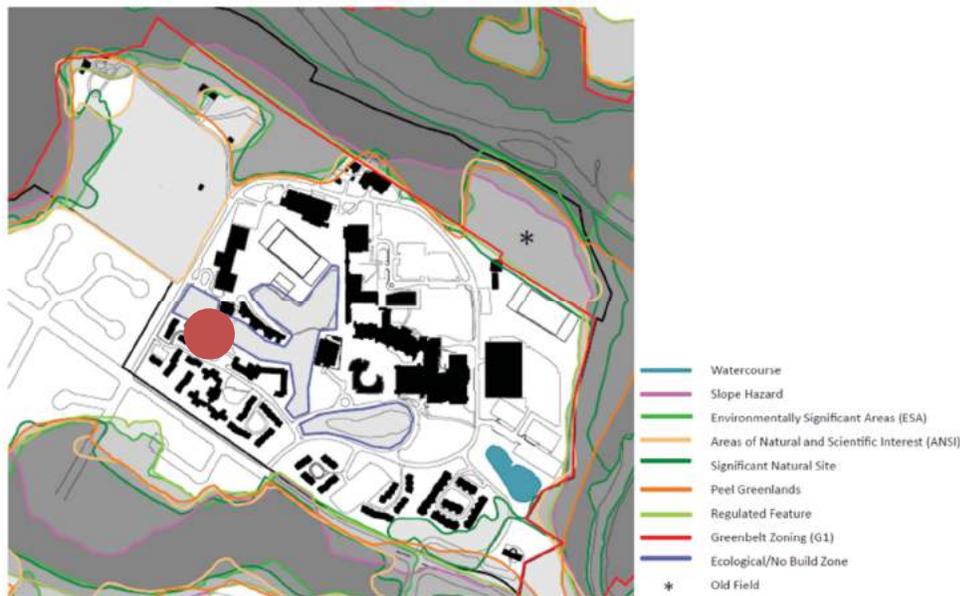
Figure 2.7 Map showing regulation of environmental features and Dot indicating Proposed Site

However, the site is adjacent to and encroaching on the ecological no-build zone, the proposed design needs to be environmentally sensitive.

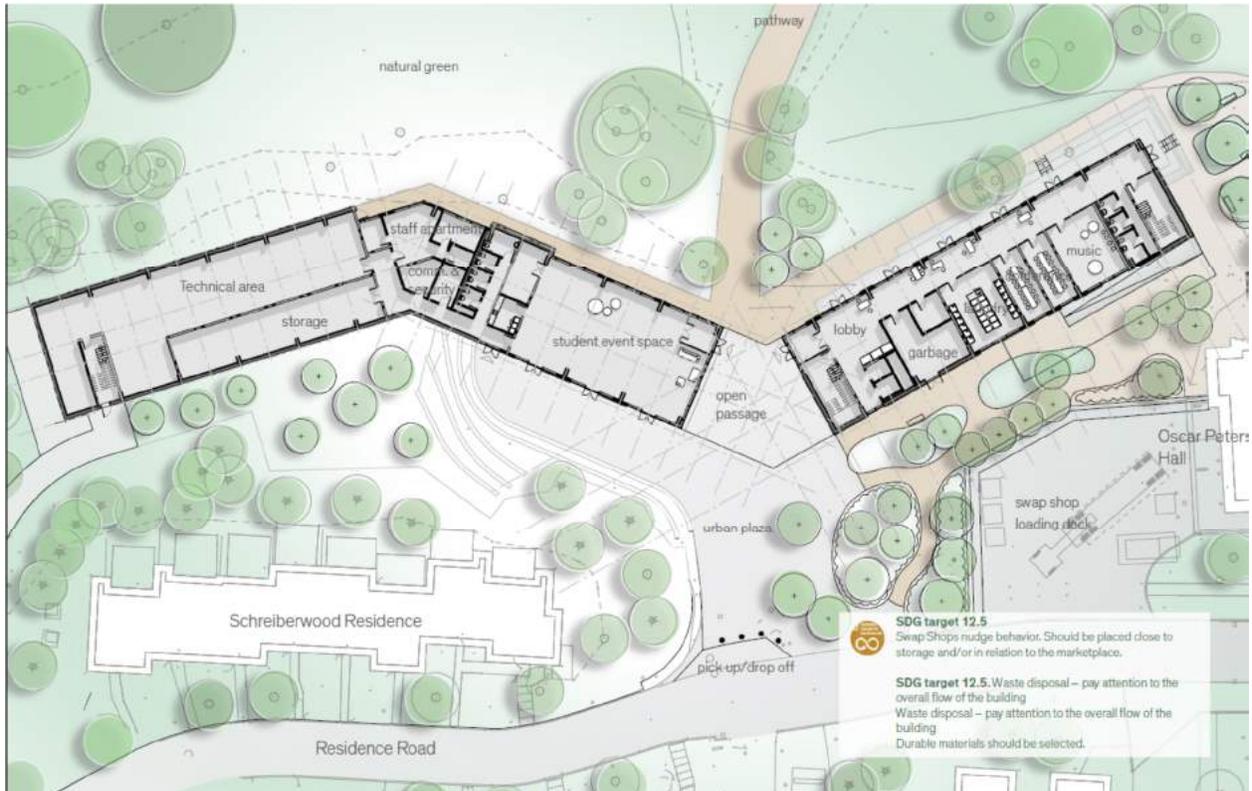
Figure 3.0, Site Access and Main Entry. (Christensen & Co/ Montgomery Sisam)

The existing pedestrian network in the area of the project relies heavily on the paved pedestrian path that connects Parking Lot #6/OPH with Deerfield Hall/Erindale Theatre/Erindale Hall. It is essential that this path, potentially reconfigured as part of the project, is reopened once the project is completed.

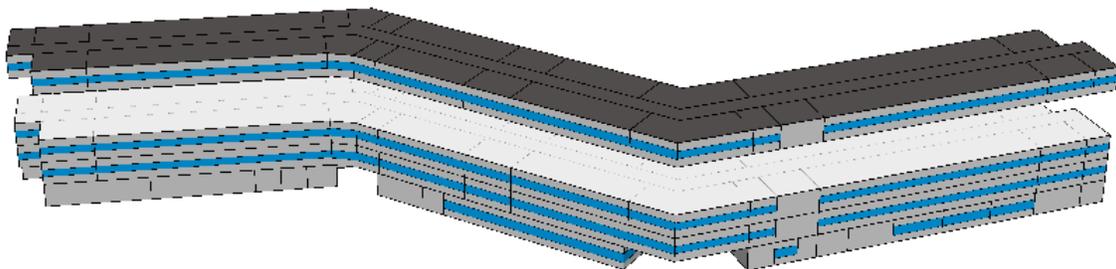
Figure-2.1: 3D Rendering of Energy Model

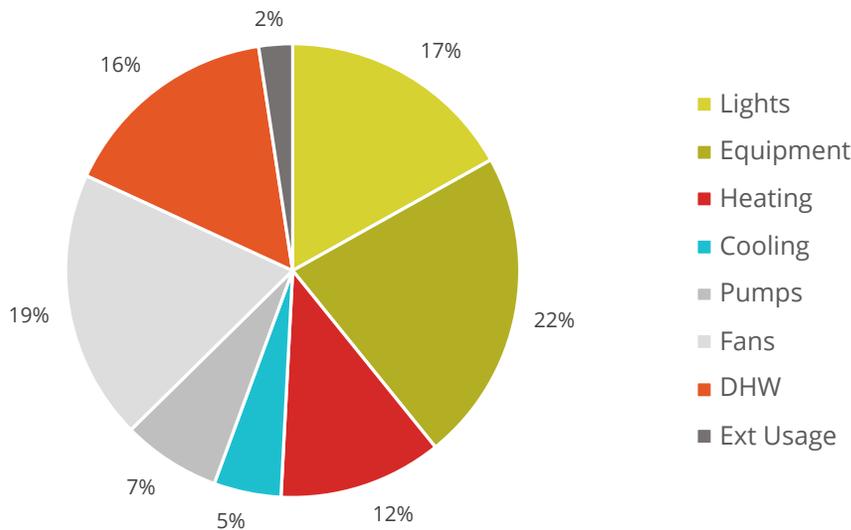
Figure-4.1: Annual building TEUI by end use
